Manhole Inspection Summary

Manhole # S17GG2020MH

Insp Date: **10/9/06 4:37 PM**

Location Address: **6000 SMITH AVE**

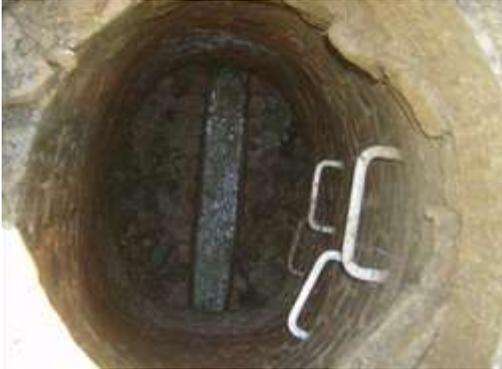
Top View

Barrel infiltration. Corroded steps.
Evidence of surcharge - Bench debris.

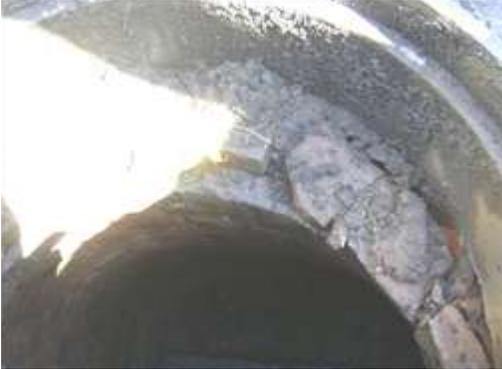
Defect

Frame leaks. Frame offset. Adjustment deterioration, loose brick and infiltration.

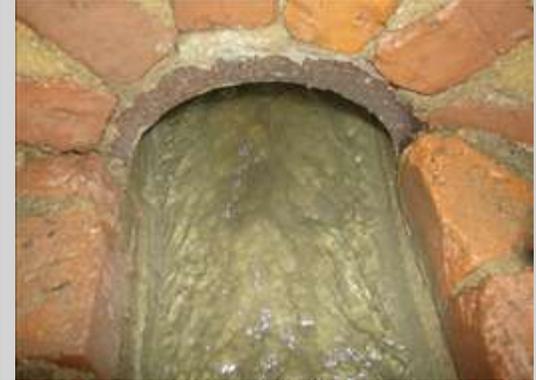
8 in. Circular Gravity Sewer Pipe Out @ 12 O'Clock

Deposits: None Mud Sludge Debris **Grease**

Silt Depth: **0** (in.) Deposits Extent: **Light**

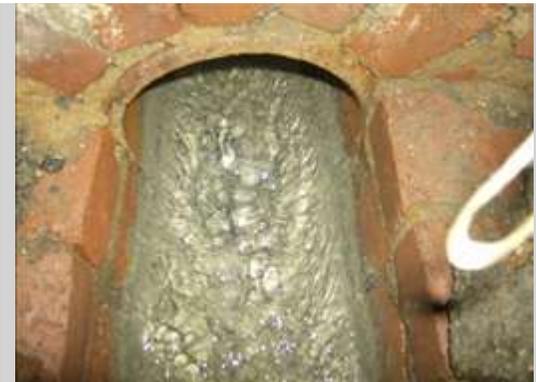
8 in. Circular Gravity Sewer Drop In @ 6 O'Clock

Deposits: None Mud Sludge Debris **Grease**

Silt Depth: **0** (in.) Deposits Extent: **Light**
